PROJECT WORKSHEET

DAMAGED FACILITY	COUNTY
Library	Monmouth

LOCATION	LATITUDE	LONGITUDE
517 10th Avenue, Belmar, New Jersey	40.17852	-74.02344

DAMAGE DESCRIPTION AND DIMENSIONS:
During the incident period of October 26 through November 8, 2012 Hurricane Sandy caused ocean storm surge, torrential rains and flooding throughout the city of Belmar, NJ. The applicant owns and has responsibility for a building being used as the City Library. The building is located in a low lying area of the city. Once storm water enters the area it cannot run out as the storm subsides but has to be pumped out. Consequently the building was only accessible by boat for a period of approximately two weeks. The building is 65 feet x 25 feet and consists of two floors. The floor of the lower level is approximately 4 feet below outside grade and is accessed by an elevator from the 2nd floor and an outside door in the rear of the building opening to a wheel chair ramp located inside the building. The storm surge reached a level of approximately 3 feet deep in the area of the city where the library is located which consequently put the water level in the lower level of the building at approximately 7 feet. As

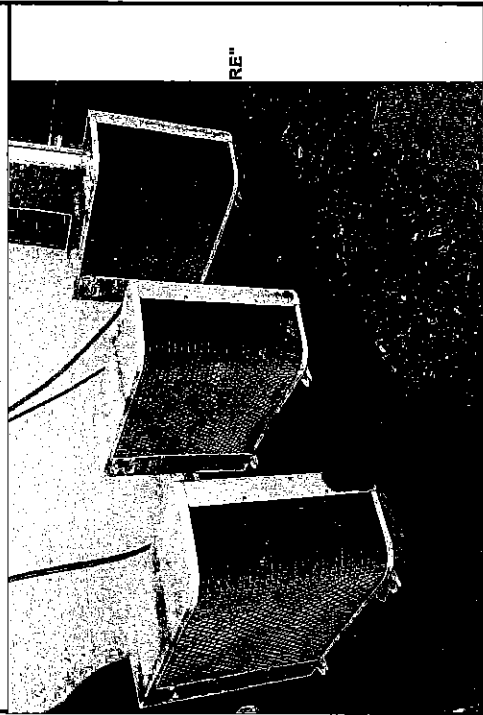
The flood water completely submerged 3 ea. heat pump compressors located outside at grade level which were part of a split heat pump system used to cool the upper level (2nd FLR).

Three damaged heat pump compressors. These compressors are sitting outside at ground level. They heat and cool the upper level 2nd floor.

Applicant has contracted with Monmouth Oil Burner & Fuel Co. to replace the 3 ea. split unit air conditioners for the upper level. Because of the mandated change in type of Freon used in air conditioners it is necessary to replace both the inside and outside units. Contract price: \$12,850.00

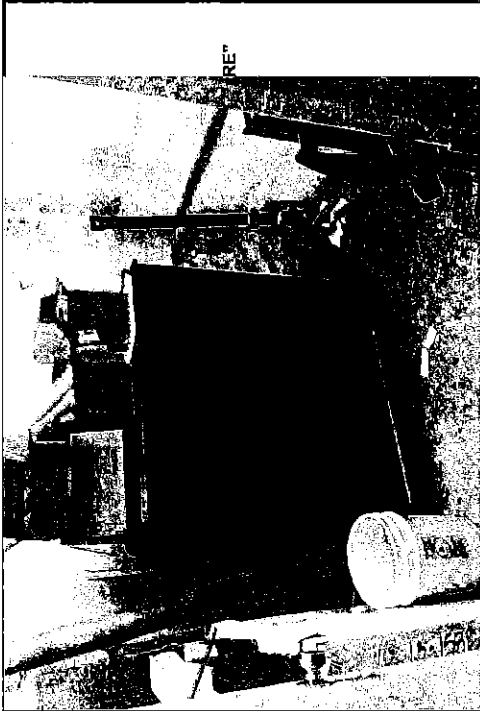
New 8 foot x 8 foot room built for new elevator hydraulic pump per building code.

3. The following materials were installed to complete the new pump room.
 - a) 15 ea. 2 IN x 4 IN x 10 FT wood framing material
 - b) 280 SF 5/8 IN FireBloc Type X sheetrock

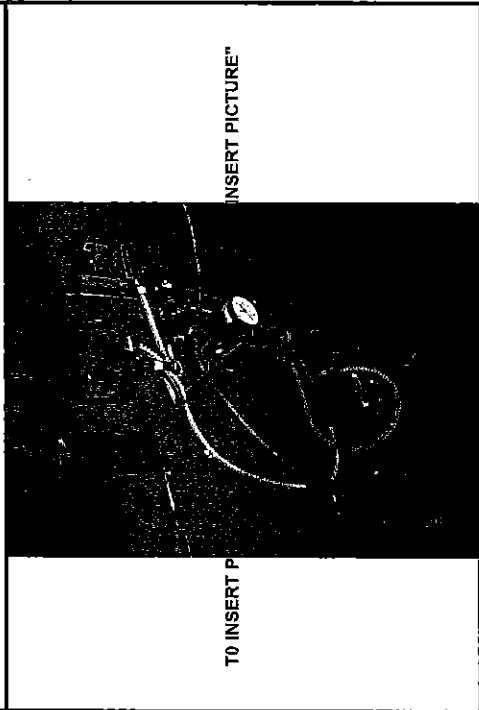
Boiler components replaced

15. Install new Weil-McLain EGH-85 natural gas steam boiler, contract price: \$9,850.00

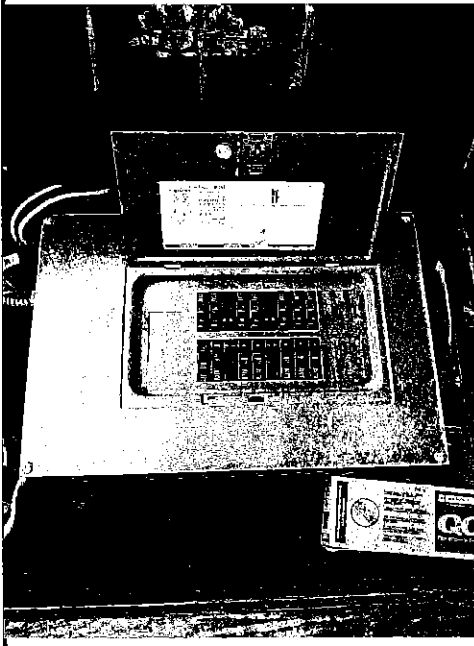
Upper level, second floor 125 amp electrical panel replaced.

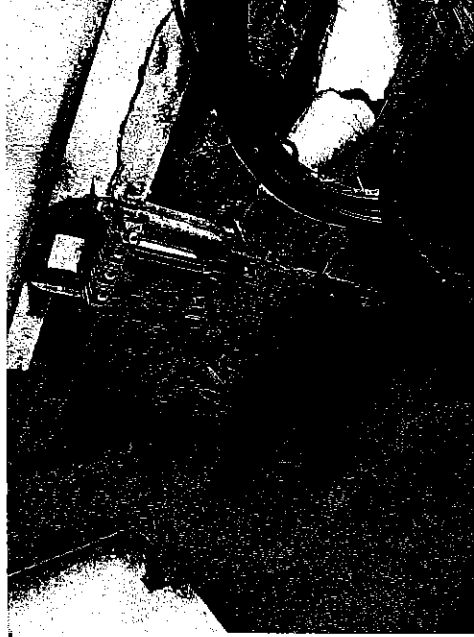
Water damaged lower level electrical panel.

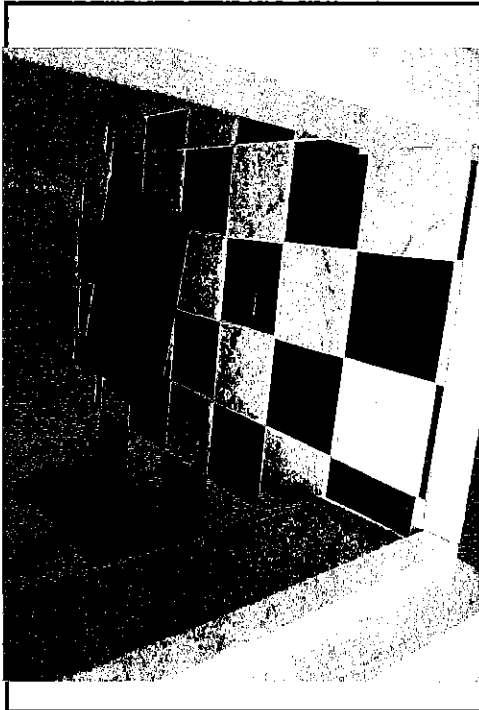
Lower level elevator lobby. New wall paint and tile.

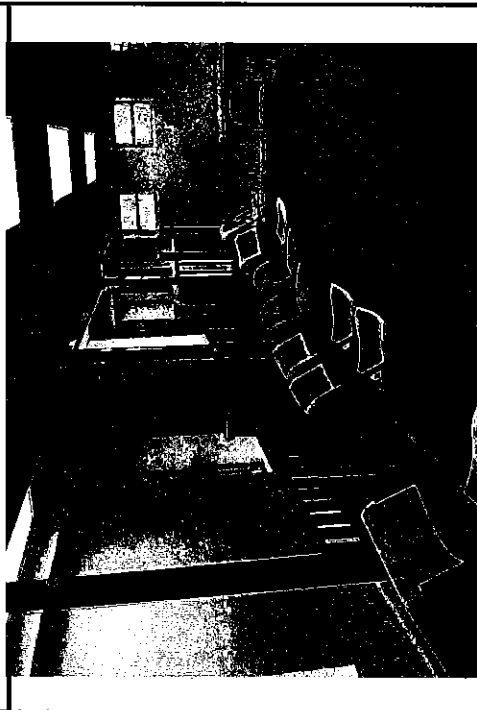
Repaired meeting room, folding chairs, wheel chair ramp with railing, painted drywall, ceiling and vinyl windows.

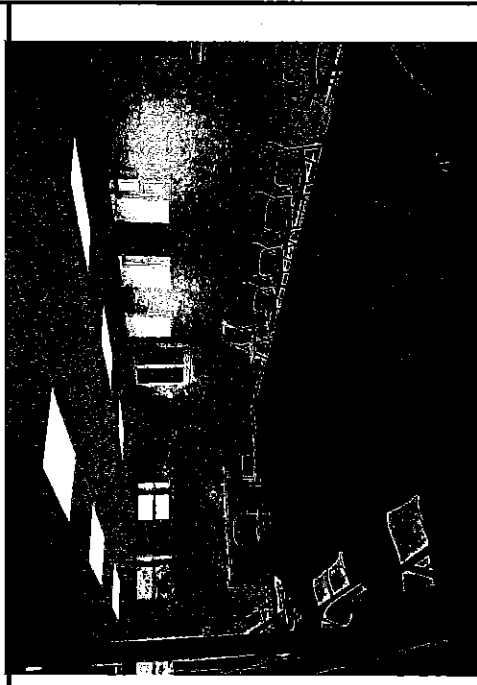
7. Six wood double hung windows: (24 IN x 24 IN) the windows were submerged in the flood waters for two weeks. Their wood sash swelled up and would not operate.

Repaired meeting room. Six new 24 inch x 24 inch vinyl double hung windows.

7. Cleaned soiled masonry walls, ceilings and floors: 6304 SF, Contract: Regency DKI Restoration, \$21,500
8. Removed wood windows and replaced with 6 ea. 24 IN x 24 IN double hung vinyl windows: the applicant could not locate the receipt for this purchase so the cost of a comparable window at Home Depot was used. 6ea, @ \$113.00 = \$678.00
